SINUMERIK 808D ADVANCED Diagnostics Manual

Diagnostics Manual

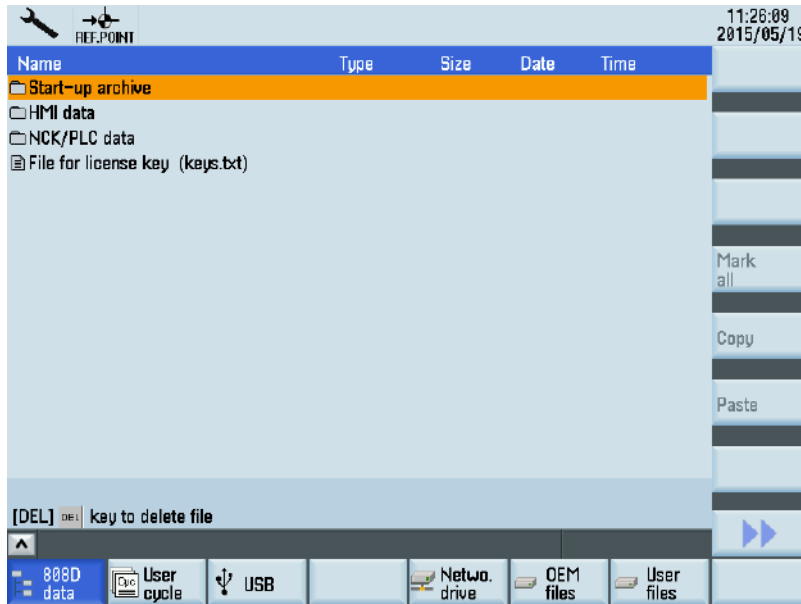
By pressing this softkey in the system data operating area, you can enter the window as follows:

Three folders and one file are available in this window. Note that the last three entries are visible with the manufacturer password only. You can import/export the subfolders or single files for backup or other customized purposes.

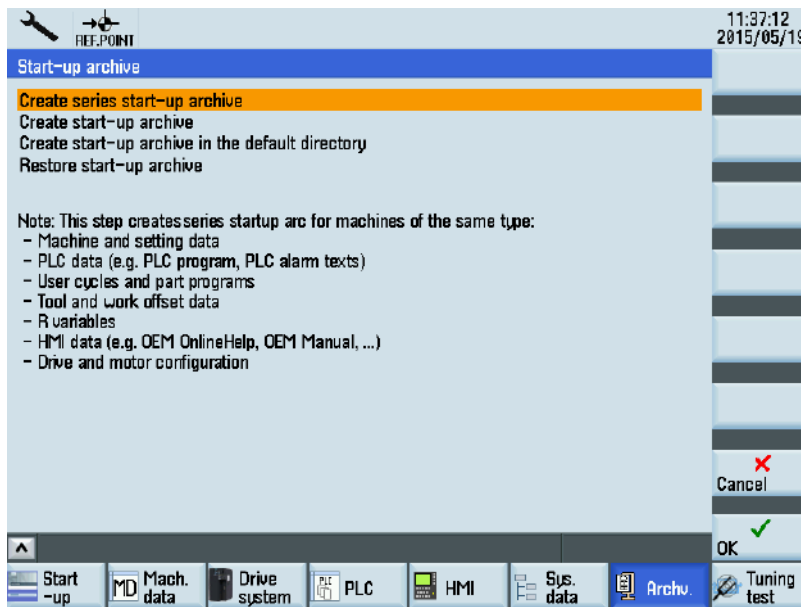
Pressing this softkey allows you to create or restore a data archive in the following window.

Note that some entries in this window are visible with the manufacturer password only. For more information, see section "External data backup in a data archive (Page 587)".

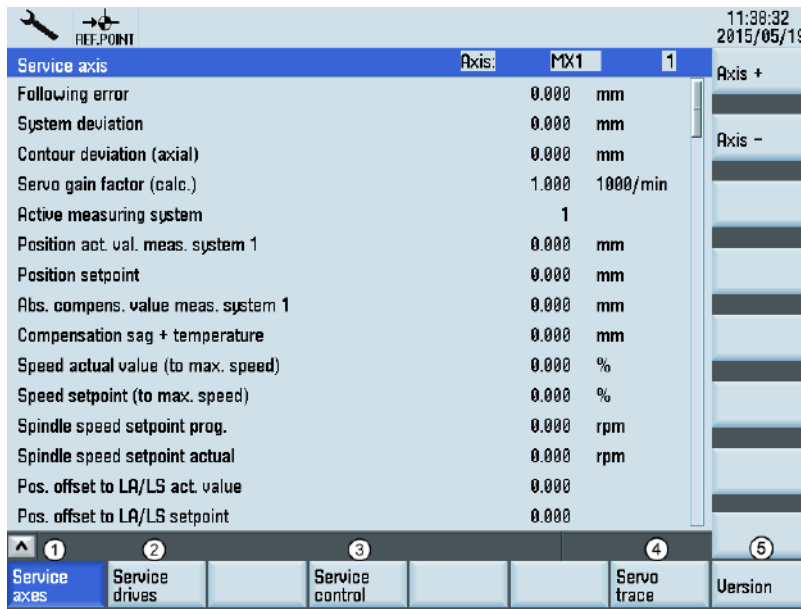
3.9 Viewing the service info

- ① Displays information of the axes.
- ② Displays information of the drives.
- ③ Displays the action log for service events, provides the possibility of sending service messages, and configures the Ethernet connection.
- ④ Compares the defined machine data with the actual data, and adjust the parameters if necessary. For more information, see Section "Servo trace (Page 43)".
- ⑤ Displays the version numbers and the date of creation of the individual CNC components. For more information, see Section "Version/HMI details (Page 45)".

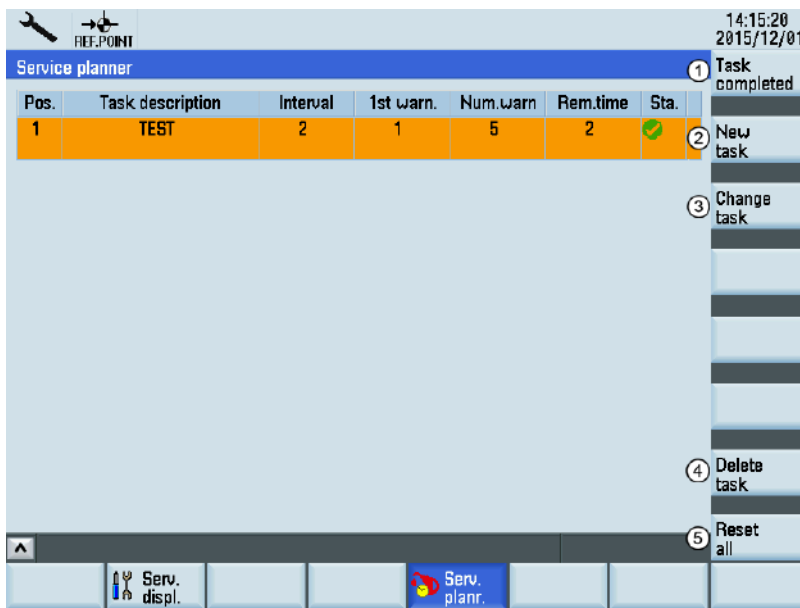
In the service planner window, you can monitor the status of the maintenance tasks and acknowledge the tasks completed.

- ① Acknowledges the selected task which has been completed
- ② Creates a new task
- ③ Changes the selected task
- ④ Deletes the selected task
- ⑤ Resets the remaining time for all tasks

Note that softkeys ②, ③, ④, and ⑤ are accessible with the manufacturer or higher-level password.

- ① Position of the maintenance task in the PLC interface
- ② Name of the maintenance task
- ③ Maximum time until next servicing in hours
- ④ Time in hours at which an initial warning is displayed
- ⑤ Number of warnings that can be acknowledged by the operator before an alarm message is output for the last time
- ⑥ Time until the interval expires in hours. The remaining time cannot be edited.
- ⑦ Display of the current status of a maintenance task
 - 🟢: The maintenance task has been started.
 - 🔴: The maintenance task is completed.
